ENGINEERING DESIGN FILE
Appendix B. CFA-10 Transformer Yard Photos

CFA-10 Transformer Yard Photos

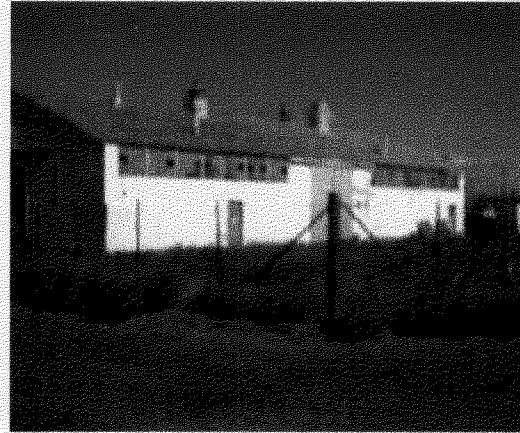
Transformer Yard from the southeast corner.

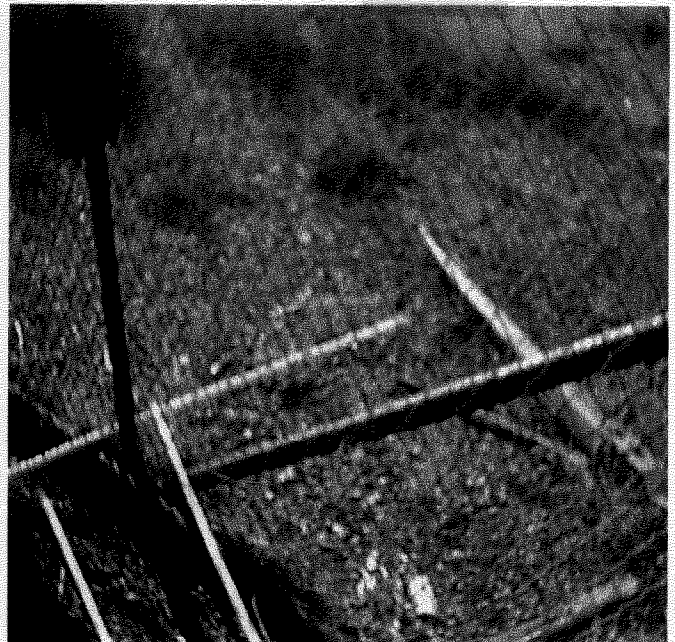
Buried lead and lead wire solder in the Columns A—K and rows. 61—70.

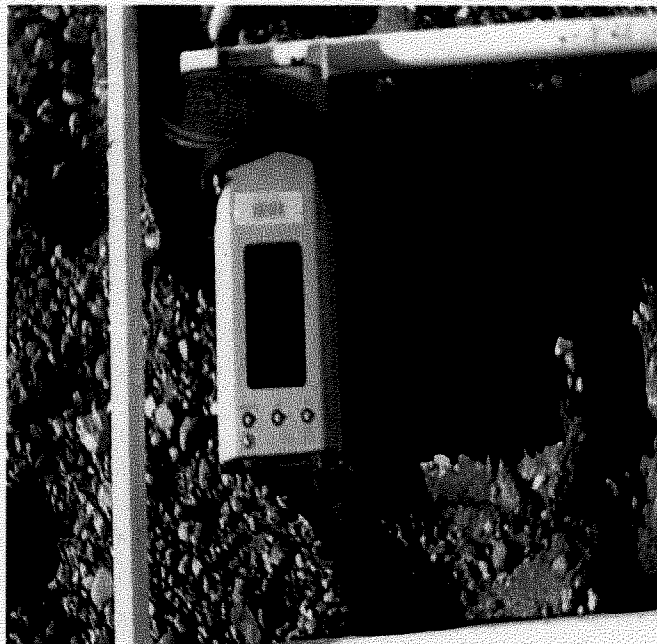
Paint Chips from the wire guard.

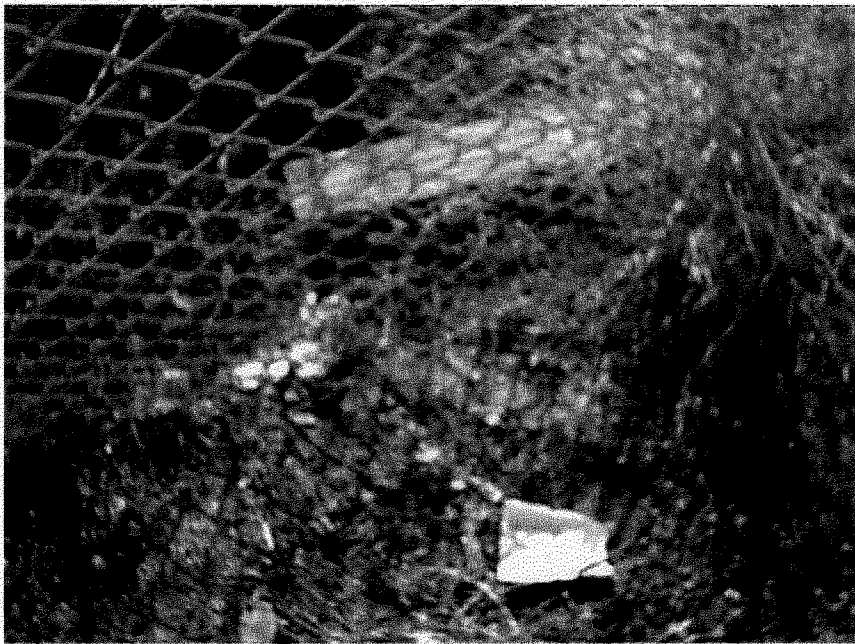
Paint chips in this area appeared to be dry flakes.

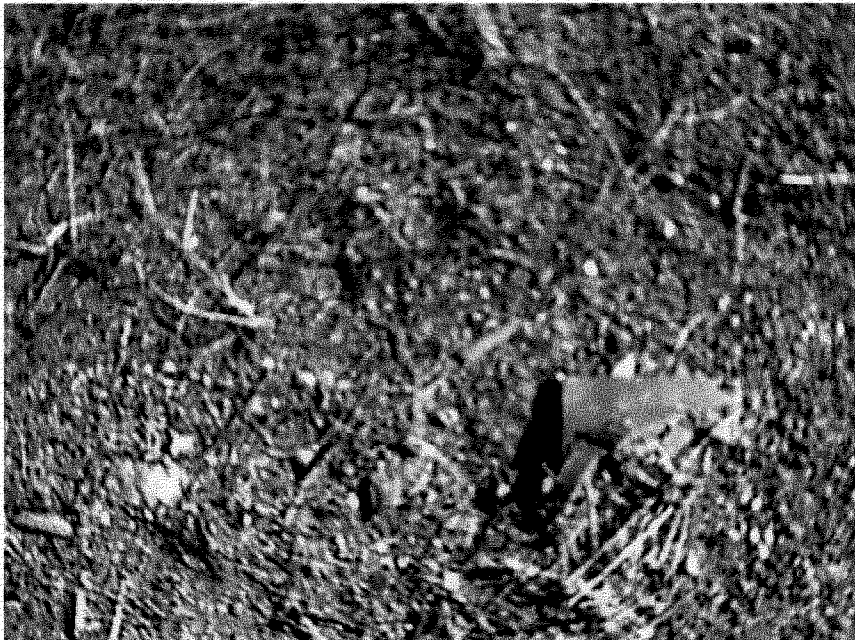
A visible lead pile collected from nearby soils.

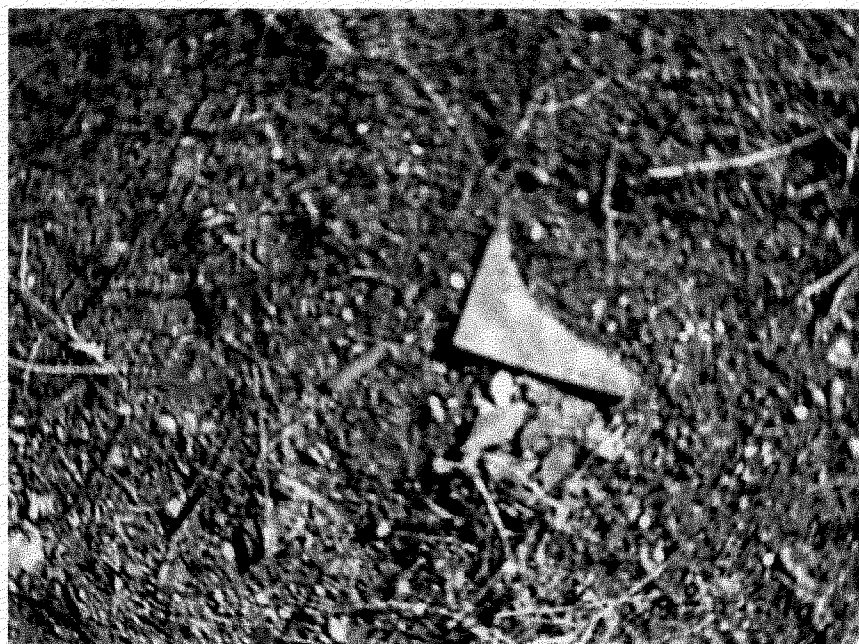
Visible lead again piled from nearby soils.

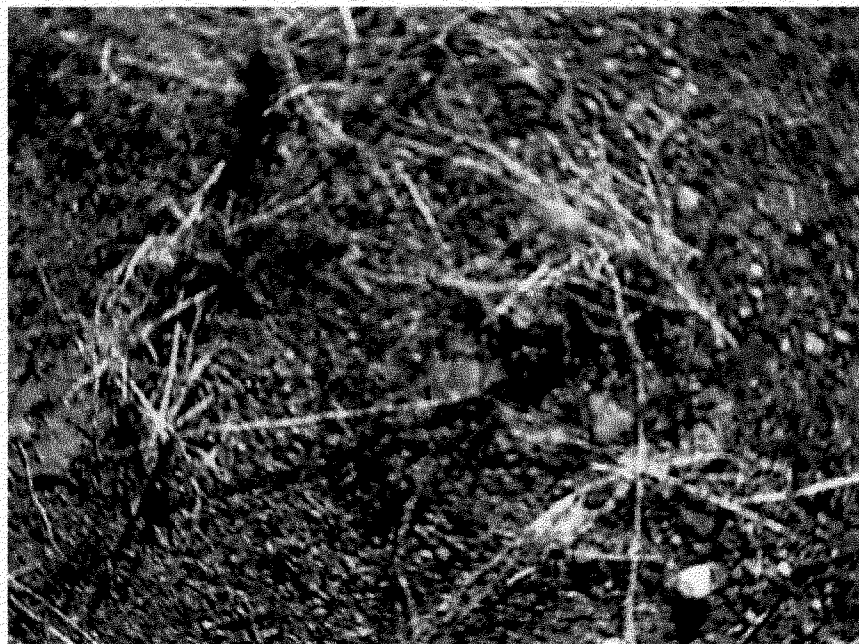
Lead spatters visible on the surface.

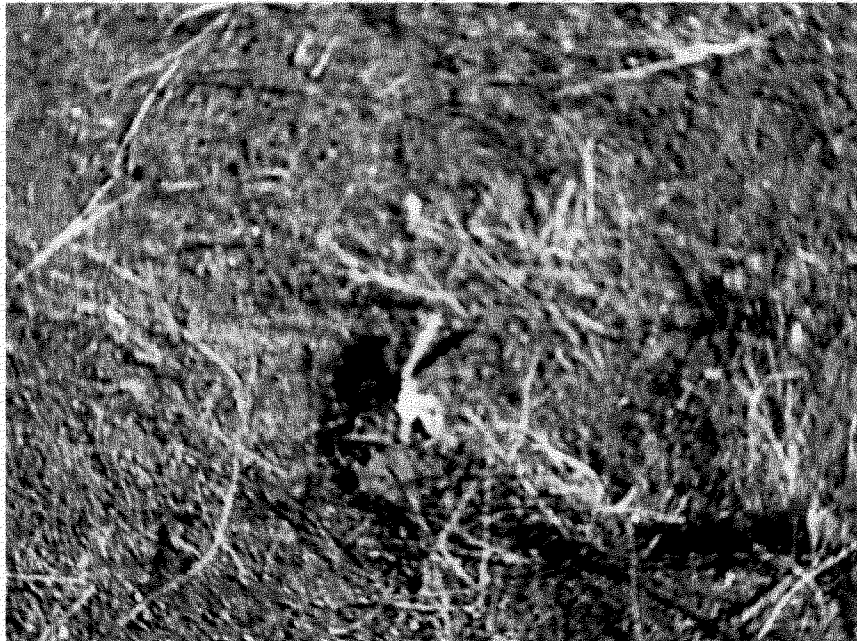
More lead spatters.

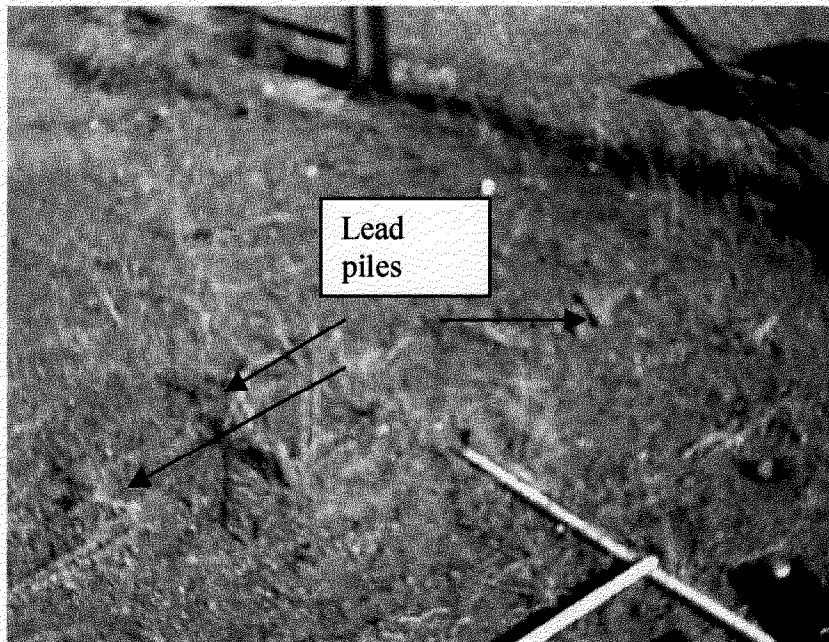
Most visible lead is in this area.

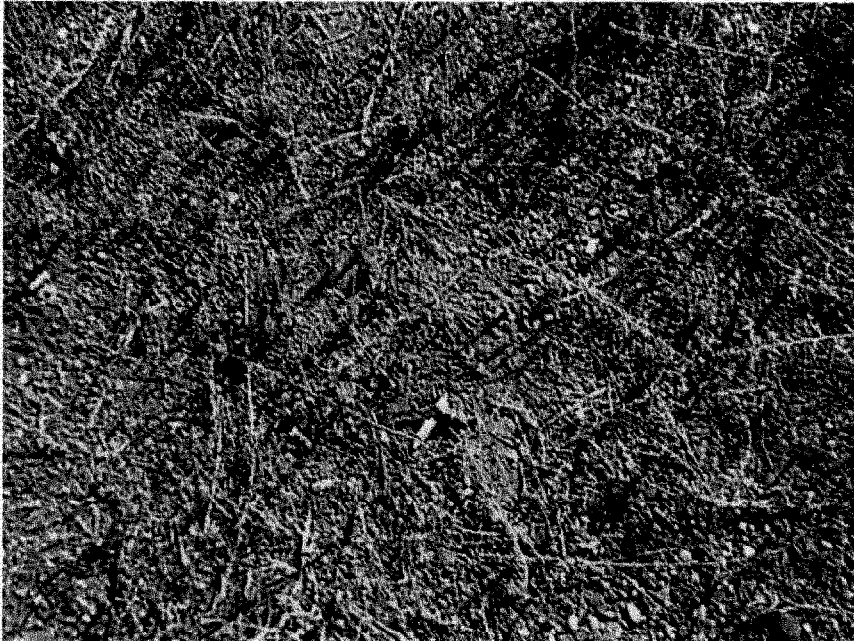
More visible lead.

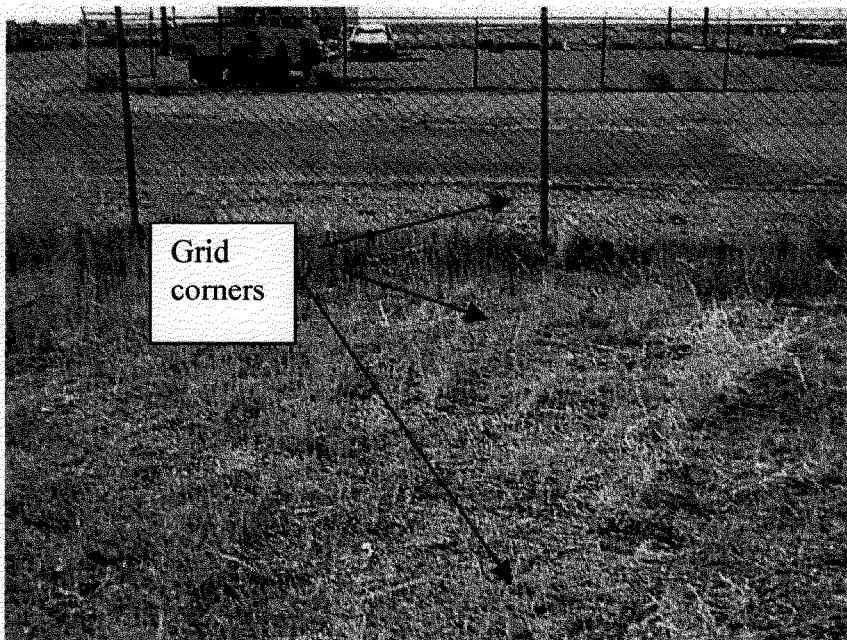
Looking south note the orange ribbons, which mark the corner grids.
